Figure 1 – Replacing Control Unit Assembly and/or B+ Terminal on N1388 Alternator

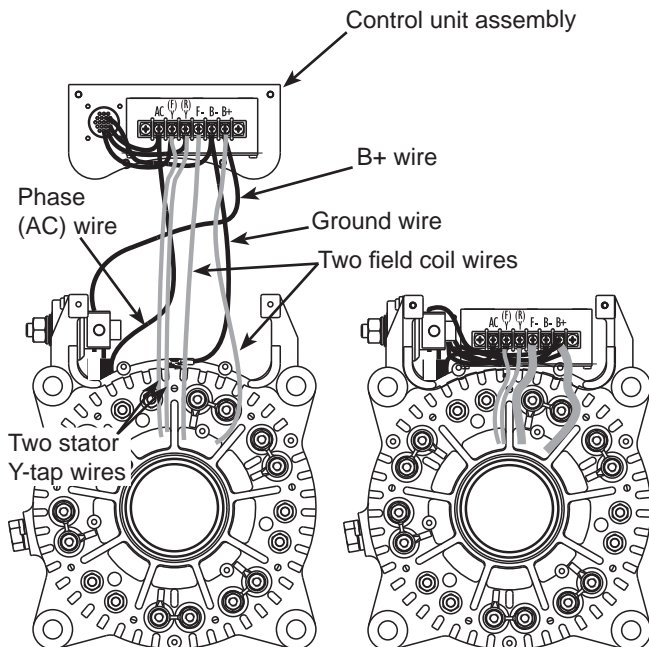
1. Remove hardware and cover plates from:
 - a. top of control unit
 - b. front of control unit
 - c. drive end housing
2. Remove and save voltage adjust plug from control unit assembly (this step is not necessary when replacing B+ terminal).
3. Carefully remove potting in front of terminal strip in control unit to expose six terminals.
4. Disconnect from terminal strip: two field coil wires, B+ wire, ground wire, two stator Y-tap wires, and phase (AC) wire.
5. Remove and save the hardware attaching the control unit assembly.
6. Carefully dig out all of the potting inside the control unit cavity. DO NOT DESTROY ANY INTERNAL WIRING.
7. Remove control unit assembly from cavity.
8. Clean out any loose debris in exposed cavity hole and from wire terminals that will be reattached to the control unit assembly.
9. **Replacing control unit assembly ONLY—proceed to step 19 on page 2.**

Replacing B+ terminal—proceed to step 10 at right.

21. Reconnect wiring removed from terminal strip. See Figure 1 on page 1 and Figure 3 below. Torque screws to 1.2 Nm/10 lb. in.
22. Apply bead of Dow Corning® SE9186L RTV coating or equivalent on mating surfaces between top control unit cover plate and drive end housing.

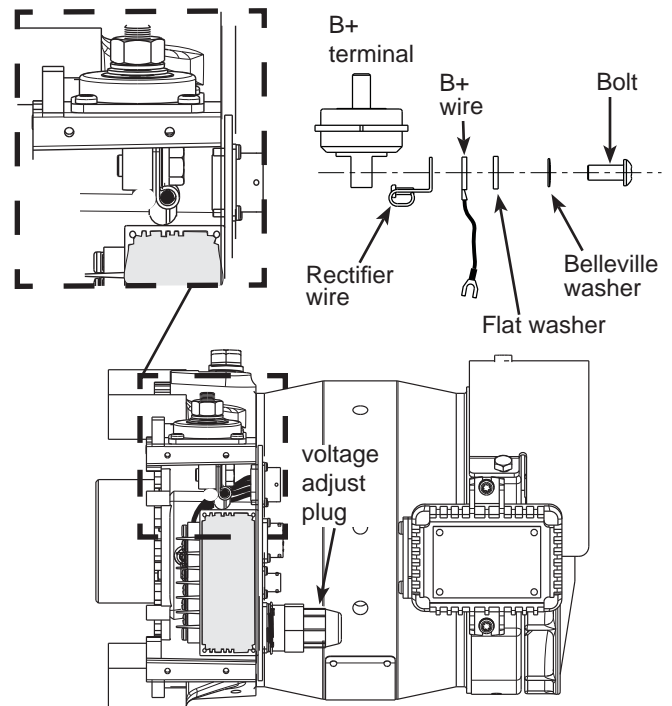
Figure 2 – Internal B+ Stacking Order

17. Reconnect wiring removed from internal B+ stack in step 11 according to the stacking order shown in Figure 2. Torque to 28-29 Nm/20.8-21.6 lb. ft.

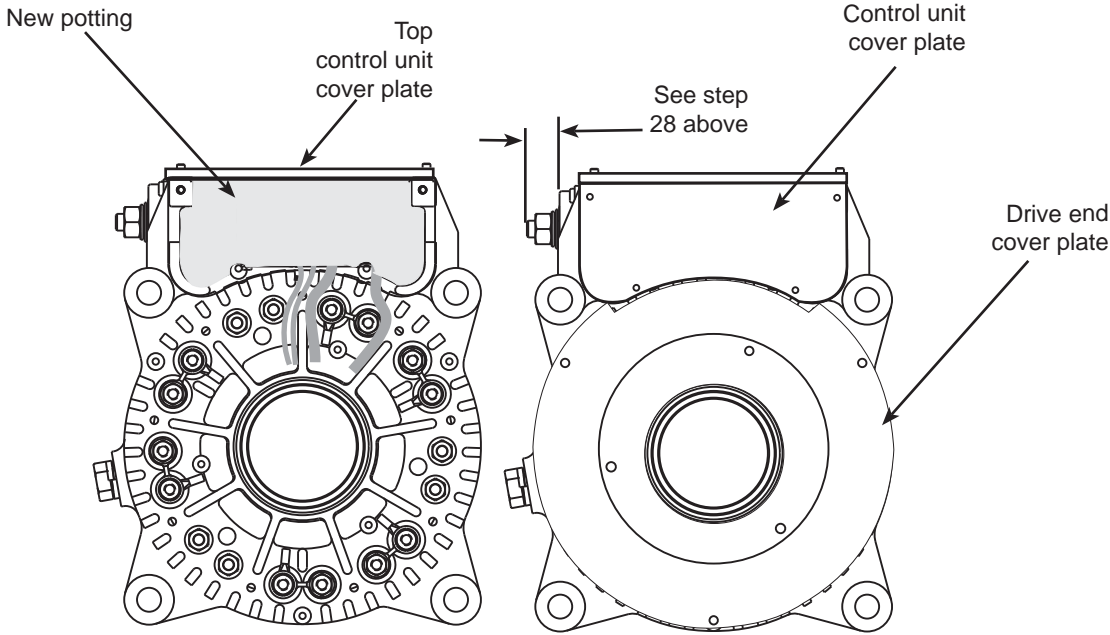
Figure 4 – Replacing Control Unit Assembly and/or B+ Terminal on N1388 Alternator

26. When new potting is dry, re-install control unit cover plate and drive end housing cover plate. Use a suitable adhesive such as Loctite® 222 on screws. Torque mounting screws to 2.3 Nm/20 lb. in.
27. Re-install voltage adjust plug in appropriate position for use.
28. If B+ terminal was replaced, re-install external hardware. Use a suitable adhesive such as Loctite® 222 on the middle of stud threads. Screw stud into terminal until only 11/16" is protruding from surface of terminal. See Figure 4.
